HUELIN McDANIELS DAM
WARREN COUNTY, MISSOURI
MO 30508

PHASE I INSPECTION REPORT
NATIONAL DAM SAFETY PROGRAM

Name of Dam: Huelin McDaniels Dam
Missouri Inv. No. 30508
State Located: Missouri
County Located: Warren
Stream: Lost Creek
Date of Inspection: May 18, 1979

HUELIN McDANIELS DAM, I.D. No. 30508

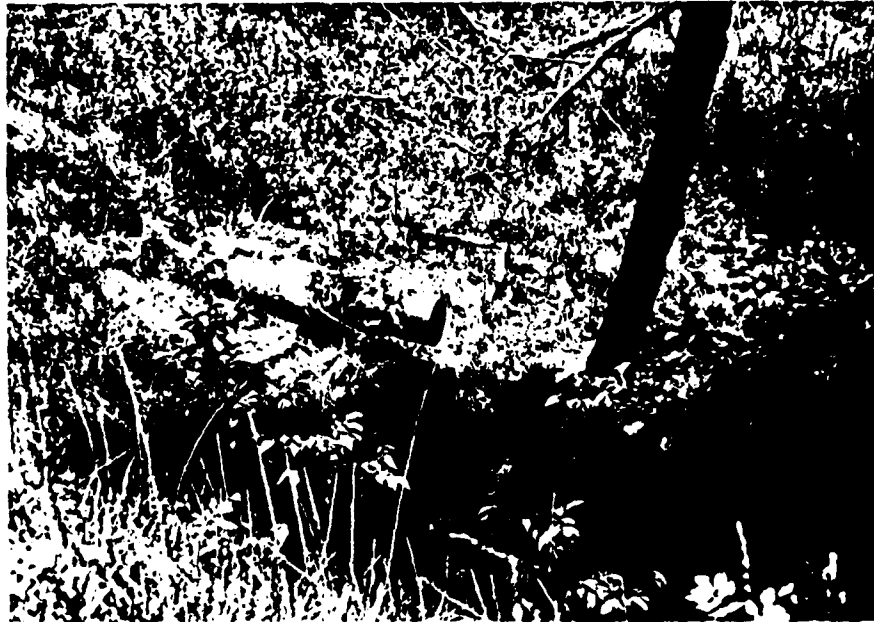
D5

A small seep was observed several feet to the right (looking downstream) and below the spillway pipe. The water at this seep was rust in color, indicating the possibility of flow along the steel spillway pipe. The seep was not a measurable amount of water.

At the outlet end of the spillway pipe and on the adjacent hillside there was a region of erosion. Some remedial measures will be required to repair this area and prevent future problems.

The seepage exiting near the service spillway pipe should be investigated. The rust color of the seepage indicates the water is flowing near the spillway pipe, which is an undesirable condition. The recommended seepage and stability study should address in detail this condition.

The emergency spillway channel should be reworked to force discharges to flow to the downstream edge of the ledge above the streambed prior to flowing into the streambed. This will prevent further erosion to the embankment material and the adjacent hillside. The eroded areas will have to be repaired by compacting earthfill into the void areas. A headwall may be required to properly stabilize the embankment material surrounding the service spillway pipe.
